LEAK TESTING SPA TUB ASSEMBLIES

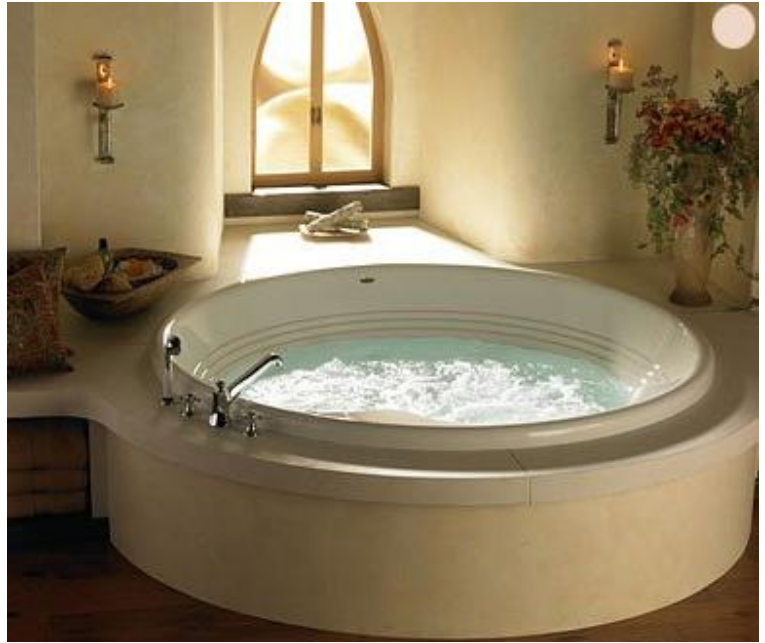
To properly assess where leaks are occurring on different spa tub designs, multiple jet ports of varying sizes and locations need to be sealed. The test system must utilize flexible technology in order to accommodate the many different tubs and sealing requirements.
