TURBO CHARGER HOUSING LEAK TESTING

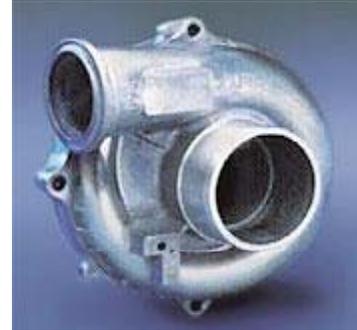
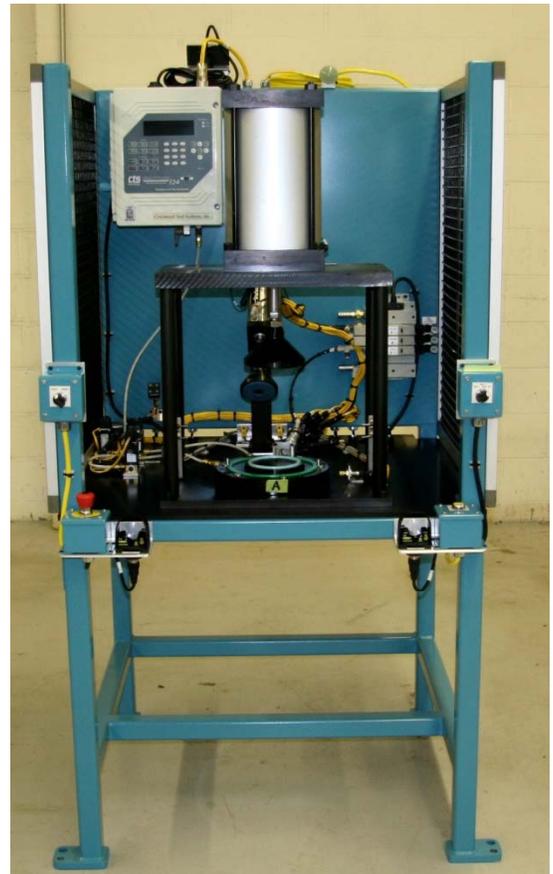
Manual load and unload pressure decay test stand utilizing a Sentinel I-24 leak test instrument. Designed to accommodate potential future robotic interface.

Turbo charger housings are typically castings that are machined for precision assembly. Both raw and machined castings are routinely leak tested to detect manufacturing flaws. Pressure decay testing to a leak rate specification of 5 sccm at 20 psig is typical.
